Executive Summary

Approximate Age of Dwelling: **New construction**

Date of Inspection: **April 16, 2005** **Time Scheduled:** **12:30pm** **Report Number:**

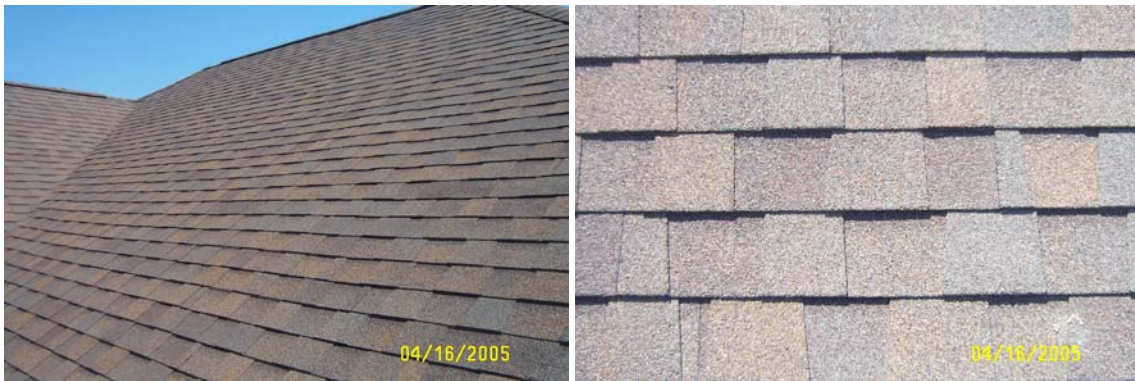
Additional Comments: Roof is approximately 1 year old, and 1 layer thick. The maximum recommended layers is 2. With proper maintenance and timely repairs when needed, this roof should last for the full design life.

The roof appears to have been professionally installed and is satisfactory at this time.

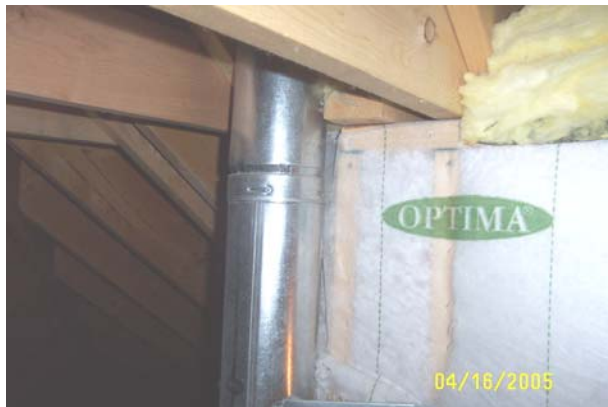
Chimney – The chimney is metal with a metal lining, rain cap and screen, and serves the furnace and water heater.

The chimney appears satisfactory as viewed from the ground, basement, and attic.

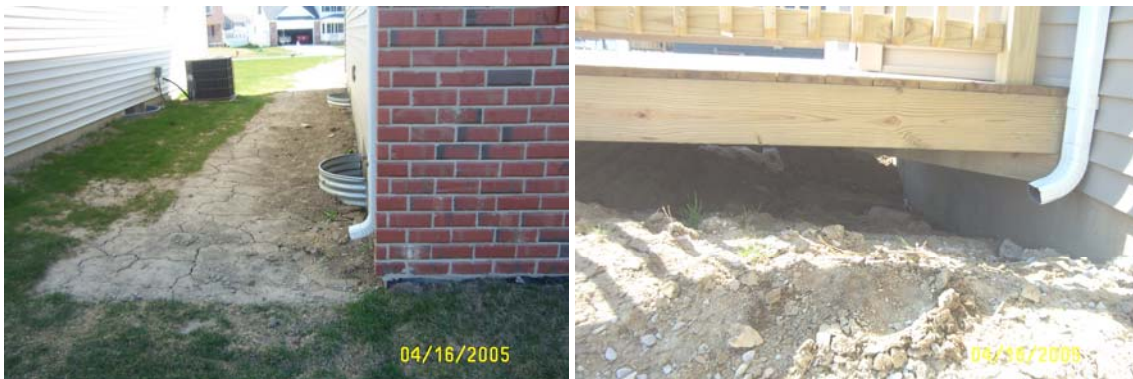
Gutters, Grounds & Property – Gutter type - **Aluminum**
Satisfactory slope for runoff? The slope on the north and south sides and at the rear is generally towards the house. This home will need to be final graded to properly slope away from the house as required by current standards.
Comments or Recommendations – Whenever possible make sure run-off drains are depositing rain water as far away from the foundation as practical.

No final grading has been done on the north, south, and east sides of the home. Each should be graded to achieve a final slope well away from the house. In
